BORDER FORTS  
NUMBERED 602, 604,  
628, AND 634  
SULAYMANIYAH, IRAQ

**SIGIR PA-05-021**

**JANUARY 31, 2006**

SUBJECT: Report on Project Assessments of Border Forts Numbered 602, 604, 628, and 634 in Sulaymaniyah, Iraq (Report Numbers SIGIR PA-05-021, PA-05-022, PA-5-023, and PA-05-024)

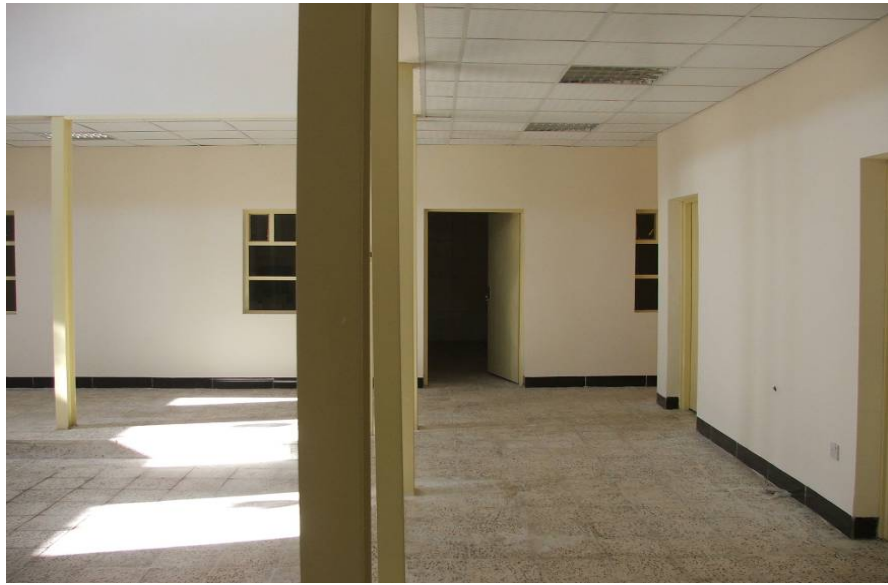
The contract and design required the construction of structural steel I-beam columns and a steel I-beam frame on reinforced concrete footings. The four border forts are scheduled for structural steel retrofit to reinforce the installed undersized and standard strength I-beams and to incorporate the additional snow load requirements. The retrofit of the structural I-beams had not commenced at the time of the site visit. The site visit revealed that several of the I-beam columns were not installed plumb and that some of the I-beam lateral members were not properly aligned. See Site Photos 1 and 2, for an illustration of I-beam columns not installed plumb at the Marwa and Issawa Border Posts. See Site Photo 3 for an illustration of an I-beam lateral member not properly aligned. Improper installation of the structural I-beams will decrease the design strength of the structure. The Contractor Project Manager said the I-beams would be re-installed correctly when the structural steel retrofit is done.

**Site Photo 1. Steel I-Beam Columns – Not Plumb (Marwa #628 Border Post)**

At the time of the site visit, the retrofit of the structural steel I-beams on the upper and lower roof had not commenced. Retrofit of I-beams is required because of the installation of undersized I-beams and the inadequate live loads used in the design calculations. Snow loads were not added to the live loads during the calculations for the structural steel requirements for the facility. The retrofit design and updated welding QC plan were being submitted to the PCO for review and approval.

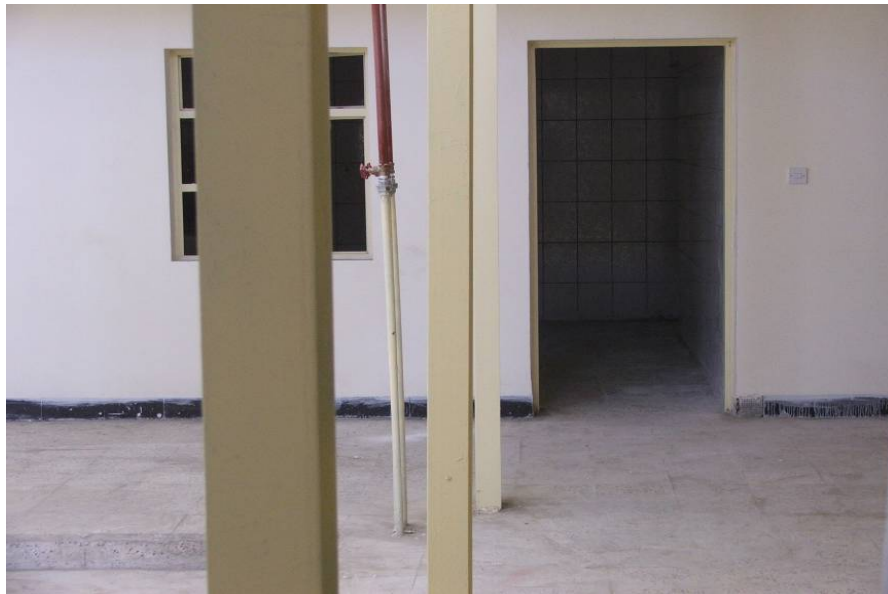
**Site Photo 2. Steel I-Beam Columns – Not Plumb (Issawa #604 Border Post)**

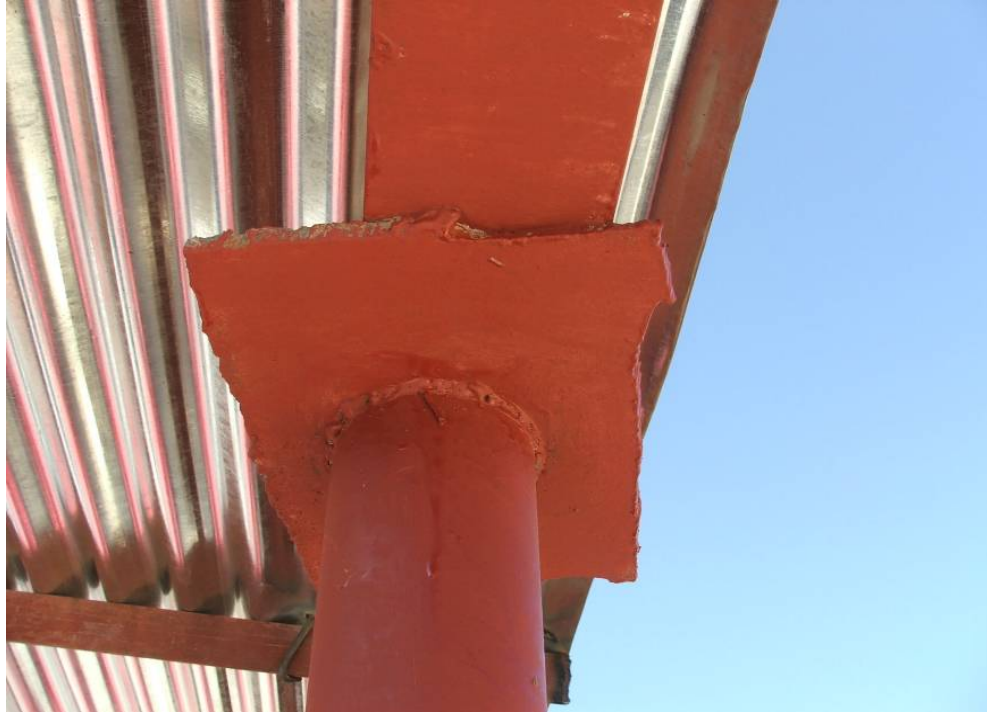
The steel generator shed, automobile parking area, and roof-mounted water tanks had a common construction deficiency. At several locations, the upper column bearing plate was only connected to the I-beam on one edge because the tubular steel columns were not properly angled resulting in a decrease in the strength of the connection due to less welded area. For illustrations of the upper column bearing plate being connected on one edge at the Issawa Border Post (Site Photos 9 and 10).

**Site Photo 4. Bearing Plate on Roof-Mounted Water Tank Canopy  
(Azmick #602 Border Post)**

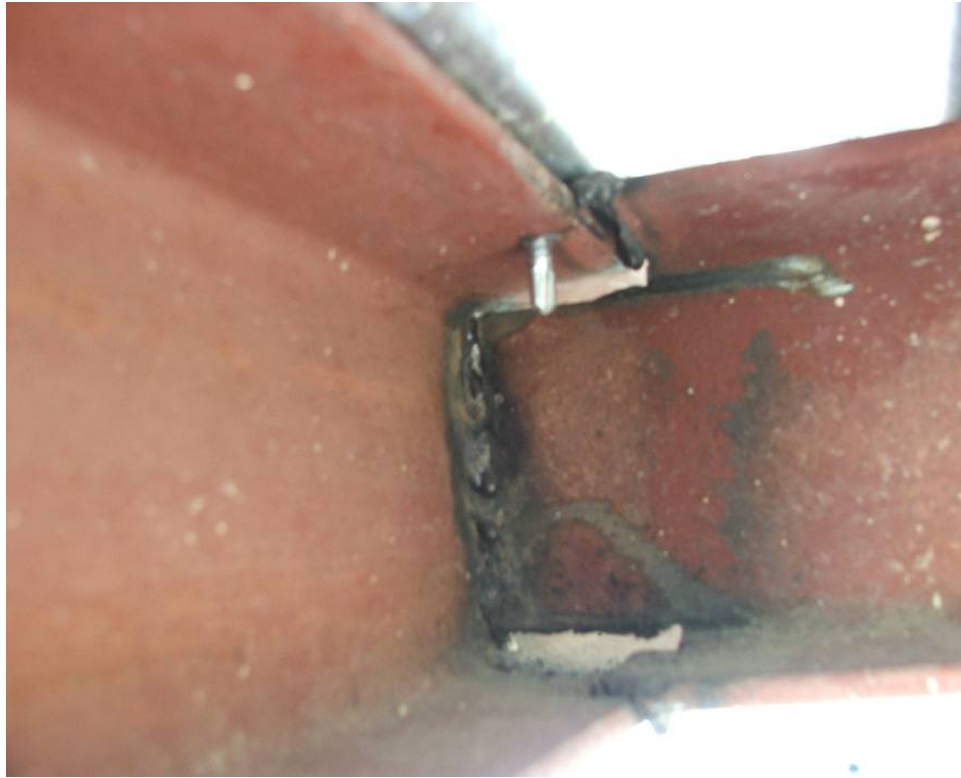
**Site Photo 6. Channel Section to Channel Section Connection  
(Marwa #628 Border Post)**

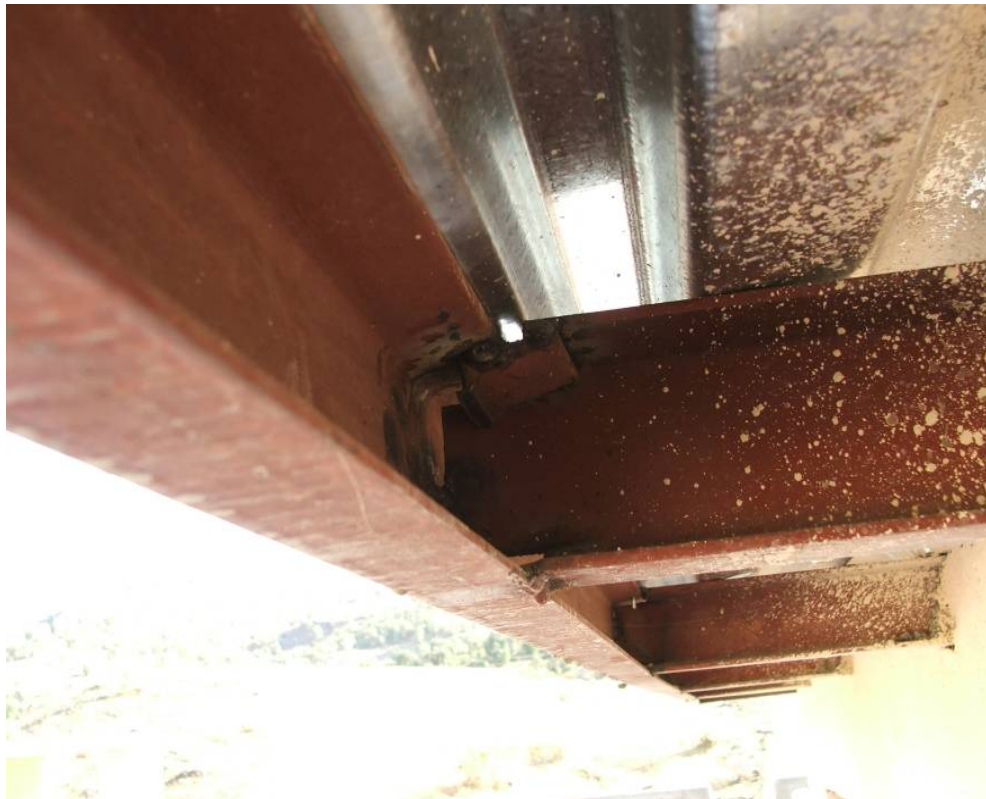
**Site Photo 7. Channel Section to Channel Section Connection  
(Marwa #628 Border Post)**

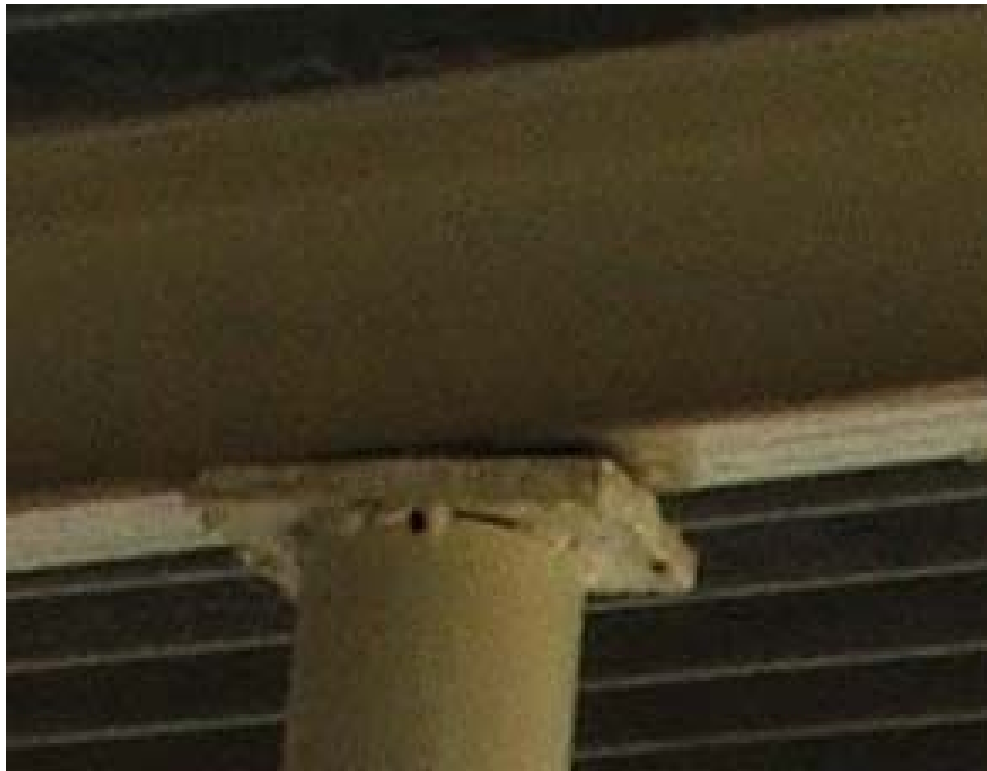
**Site Photo 8. Upper Column Bearing Plate Showing Incomplete Welds  
(Safrah #634 Border Post)**

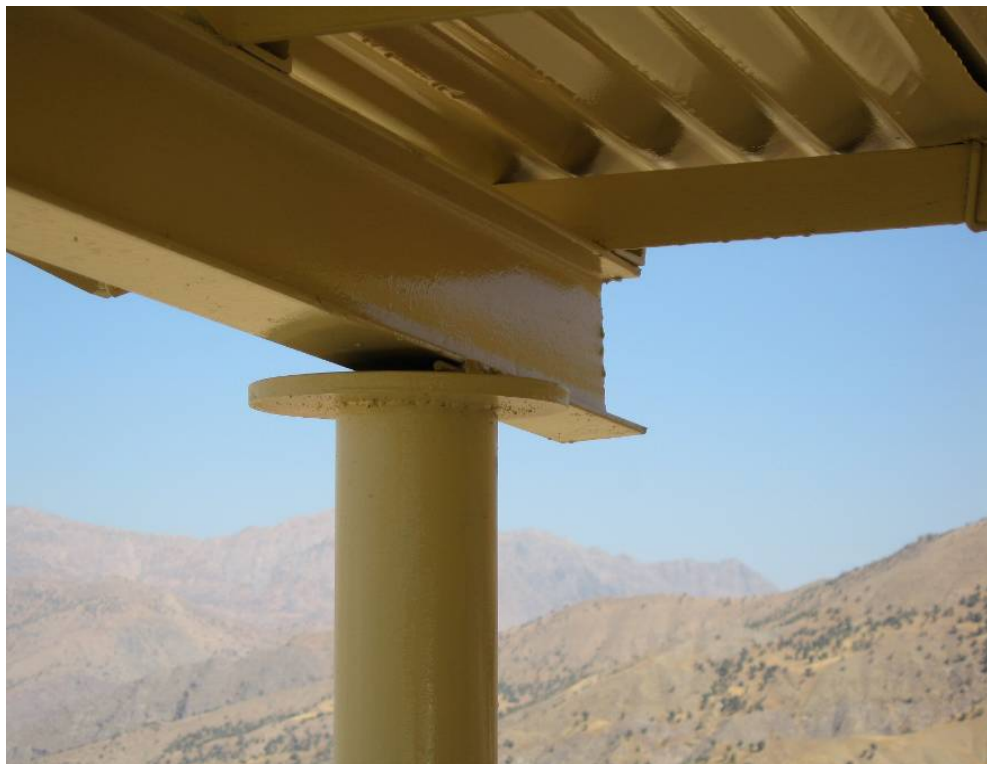
**Site Photo 9. Upper Column Bearing Plate Only Connected On One Edge  
(Issawa #604 Border Post)**

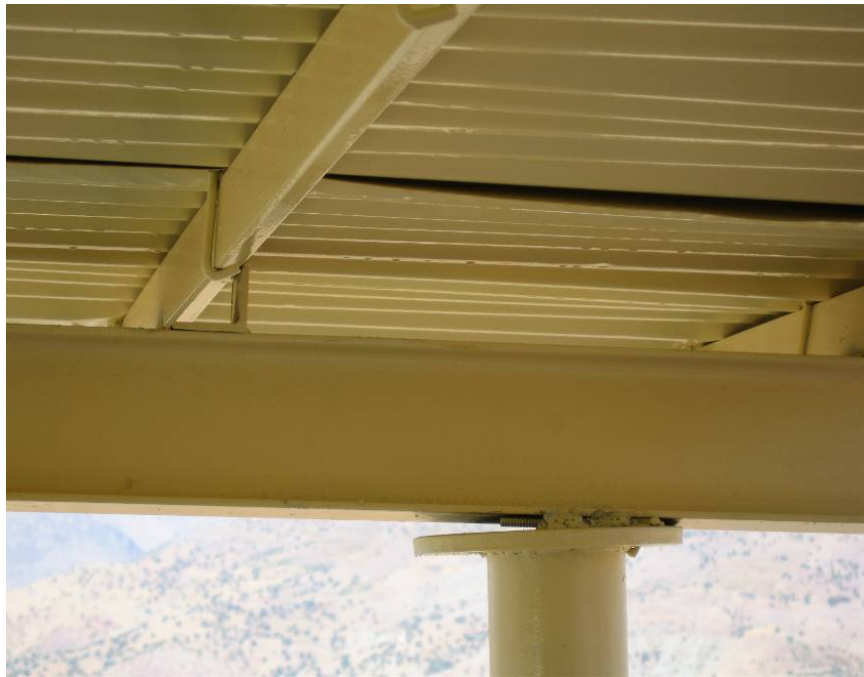
**Site Photo 10. Upper Column Bearing Plate Only Connected On One Edge  
(Issawa #604 Border Post)**

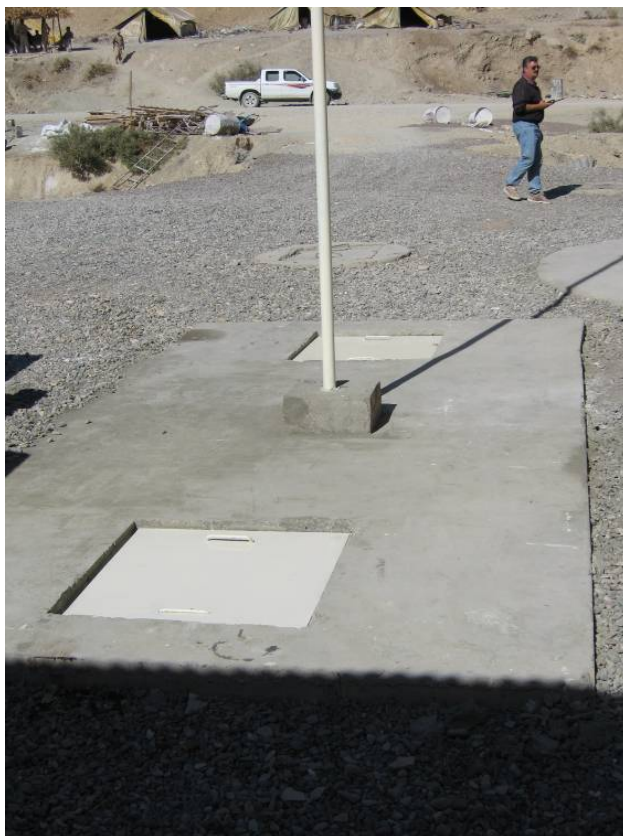
The contract and design required the construction of two septic tanks and four soakaways for collection and disposal of wastewater, including all required associated pipes and fittings. During the site visit, we verified that the construction of two septic tanks and four soakaways was completed. Site Photo 26 shows the top cover surface of one of the septic tank with two access ports and Site Photo 27 shows one of the soakaways. The soakaway access port was made of concrete, appeared to be poorly constructed, and showed signs of deterioration.

**Site Photo 26. Septic Tank (Safrah #634 Border Post)**

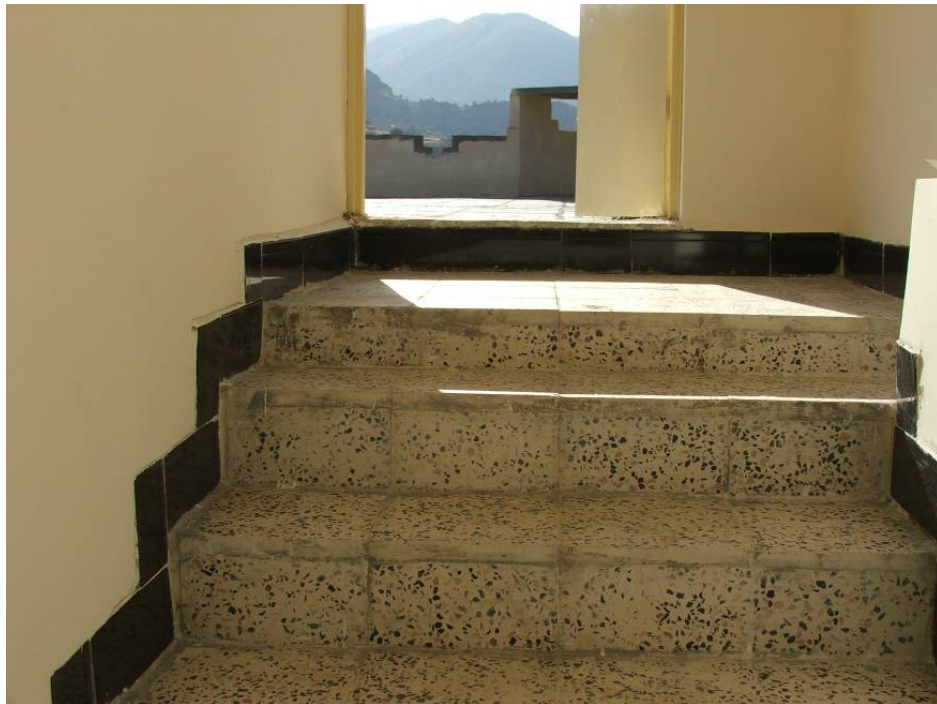
The design required the rise for the steps or the internal stairwell to be 18.7 cm (7.4 in) and the run to be 30 cm (11.8 in). Based on measurements obtained during the site visit, the rise varied between 6 in and 9.5 in, although the run was consistent at 12 in. See Site Photo 32 for an illustration of the interior stairwell steps.

**Site Photo 32. Interior Stairwell Steps (Marwa #628 Border Post)**

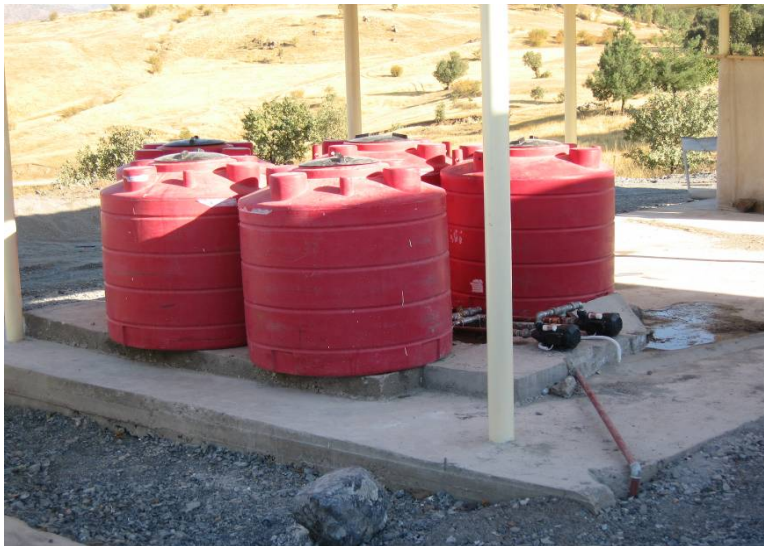
**Site Photo 37. Ground-Mounted Water Storage Tanks  
(Marwa #628 Border Post)**

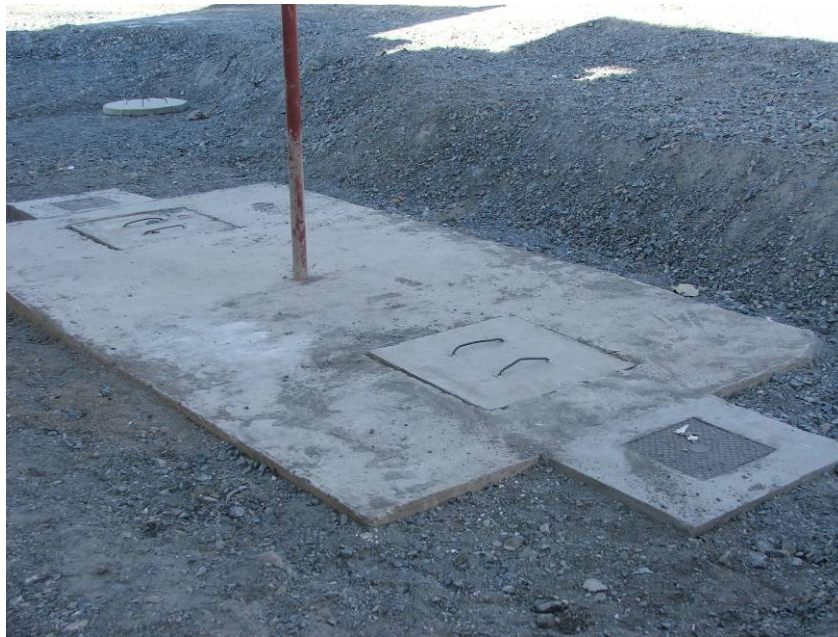
The contract and design required the construction of two septic tanks and four soakaways for collection and disposal of wastewater. In addition, the contract required all associated pipes and fittings for the septic tank and soakaways. The site visit verified that the construction of two septic tanks and four soakaways was completed. For an illustration of the top cover surface of one of the septic tanks with four access ports and two soakaways, see Site Photo 38. The design required two cast iron access ports. The site visit verified four access ports per septic tank, two concrete and two metal.

**Site Photo 38. Septic Tank with Four Access Ports  
(Marwa #628 Border Post)**

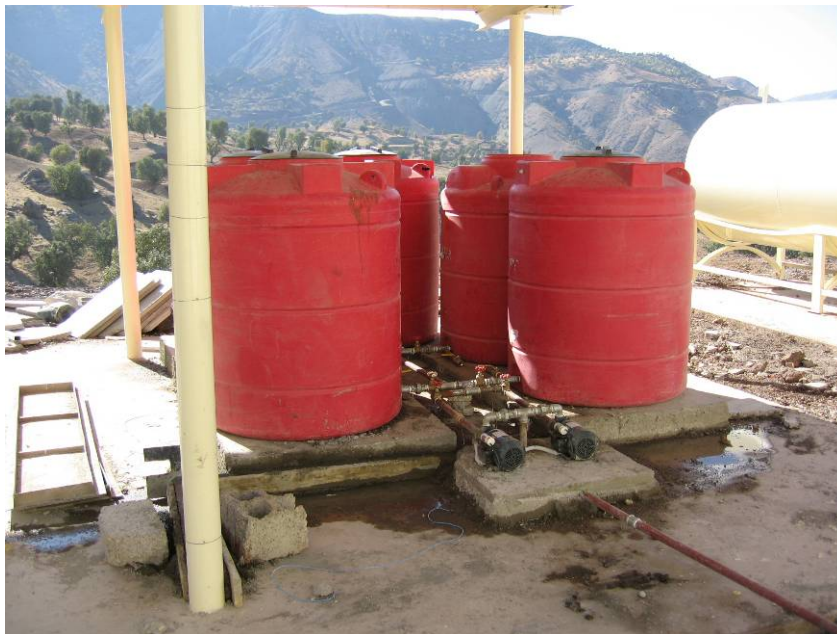
The location of the ground-mounted water storage tanks was not consistent with the design requirements. The ground-mounted tanks were to be located underneath a separate steel framed canopy. During the site visit, the water tanks were located under the automobile parking steel canopy. In addition, the design required anchor bolts to be imbedded in the concrete footing, and the tubular steel columns connected to bearing plates, which would then be bolted to the footing. During the site visit, anchor bolts were not visible.

**Site Photo 47. Ground-Mounted Storage Tanks, Pumps, and Piping  
(Azmick #602 Border Post)**

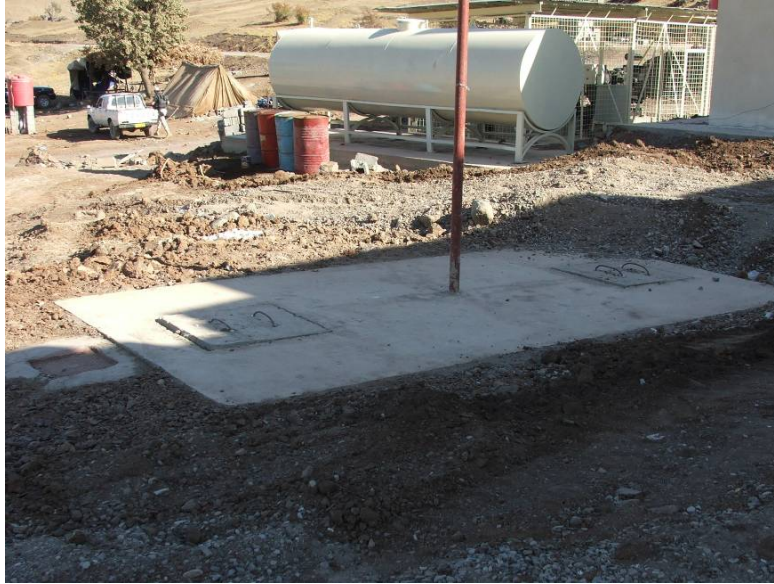
and two soakaways, see Site Photo 48. The design required two cast iron access ports; however, the site visit verified that there were four access ports per septic tank, two concrete and two metal.

**Site Photo 48. Septic Tank and Access Ports  
(Azmick #602 Border Post)**

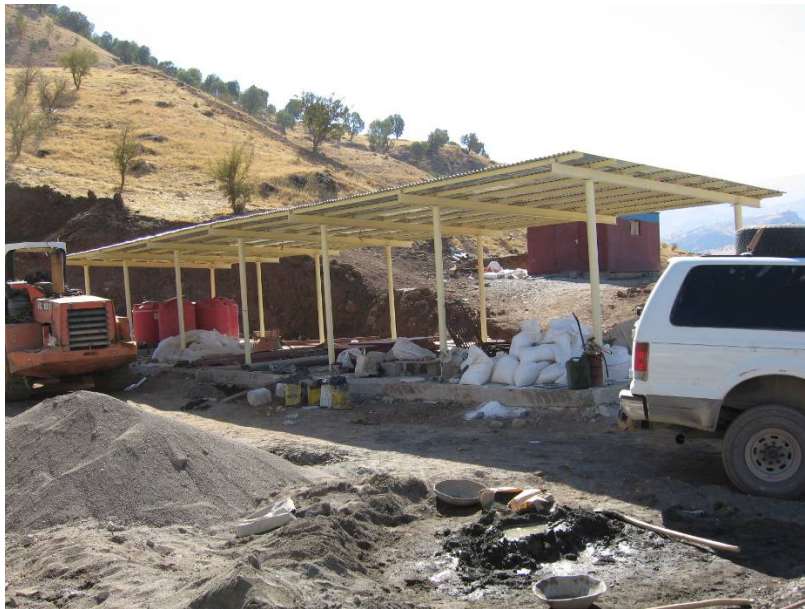
The contract and design required the construction of a covered automobile parking area. The covered automobile parking area was to consist of a reinforced concrete slab with steel framed structure and a corrugated steel canopy. The site visit verified that the automobile parking area was constructed. The side of the concrete pad showed areas of segregated concrete as well as a lack of sub-base to support the concrete pad. For an illustration of the automobile parking area, and the segregated concrete with the lack of a sub-base, see Site Photos 59 and 60, respectively.

**Site Photo 59. Automobile Parking Area (Issawa #604 Border Post)**

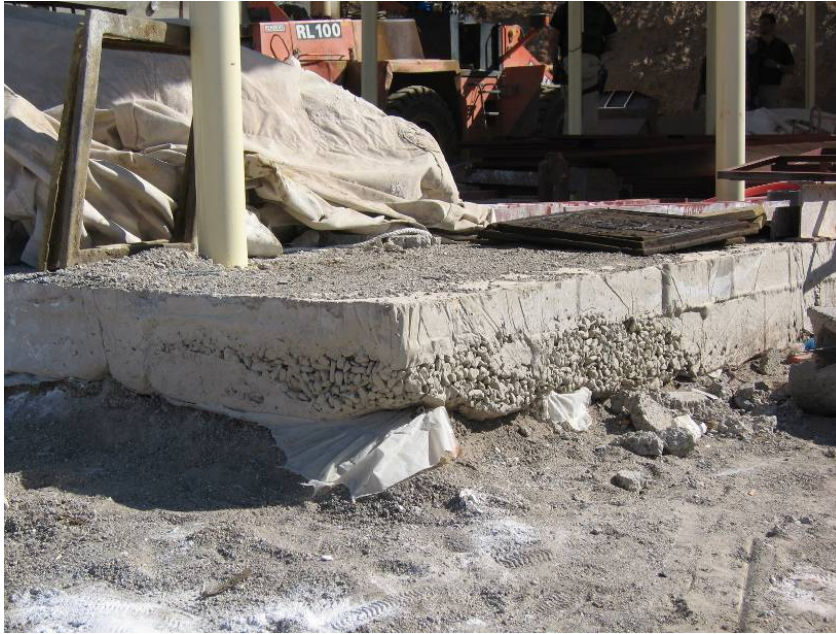
**Site Photo 60. Concrete Pad of Automobile Parking Area  
(Issawa #604 Border Post)**
